NATIONAL SYMPOSIUM ON SOIL BIODIVERSITY 2013

Conservation and Sustainable Use of Soil Biodiversity in Sri Lanka

**PROPERTIES OF SOIL AND PLANT BIODIVERSITY IN THE LANDSLIDE PRONE
AREA OF NIKOLA OYA, RATTOTA**

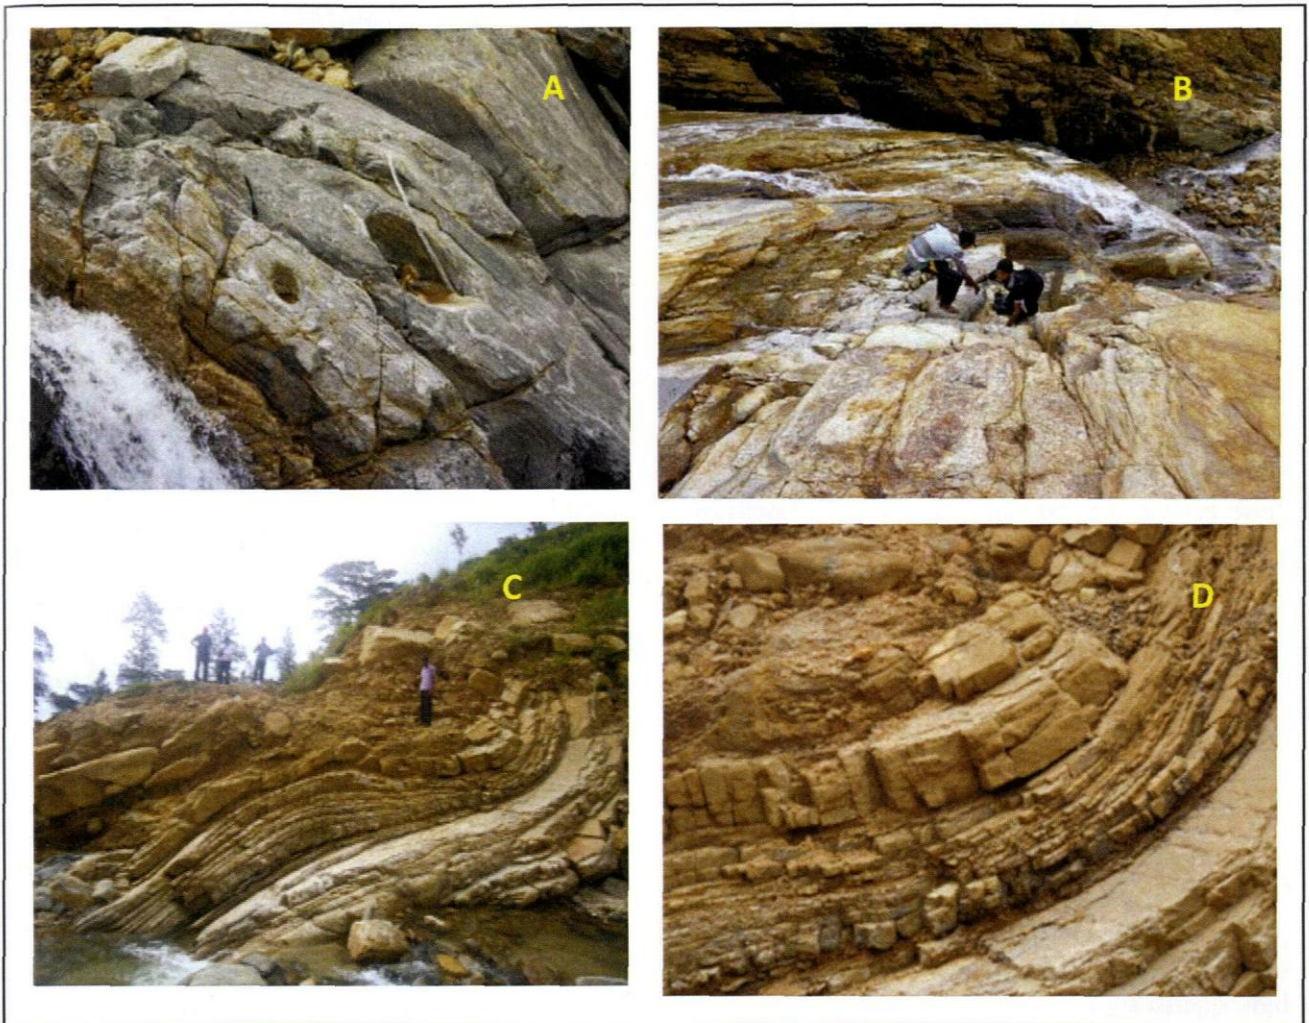
Figure 1: Photos A-D show that the highly weathered undifferentiated charnockitic biotite gneisses (A & B), Quartzites (pure coarse-grained ridge forming quartzites locally with <5% each of sillimanite, kaolinized feldspar or biotite (C & D)).

North-east of the Kandy Plateau is the Knuckles Massif, with several fine mountains over 1,600m, its highest peaks are Gombania (1,905m) and Knuckles (1,863m). The knuckles Massif is really a complex of ranges resulting from a large recumbent fold, and some of finest and most rugged mountains in Sri Lanka are to be found in this comparatively inaccessible and little known region (Cooray, 1984). Long escarpments, some rising over 900m in sheer rock walls are also common, particularly in the Knuckles area. These escarpments may be the results of faults but more often they are the result of jointing and some are resulted from the branching of long anti-clinal folds. Main rocks of the study area are Granite gneiss, undifferentiated charnokitic biotite gneisses, Quartzites (pure coarse-grained ridge forming quartzites locally with <5% each of sillimanite, kaolinized feldspar or biotite: Figure 1).

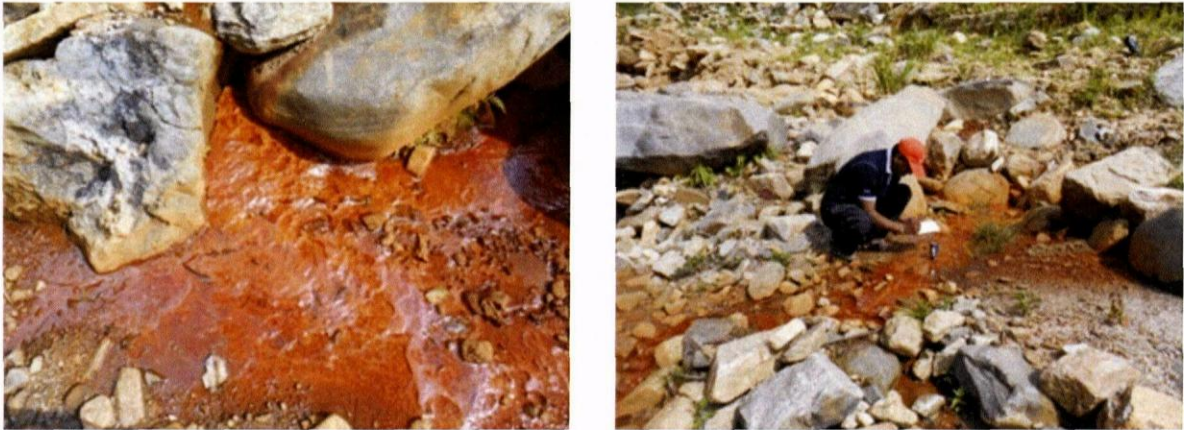
Figure 3: Photos show that under the intense chemical weathering, *hydrated oxides* of Aluminum (bauxite) and Iron (goethite) concentrated water pockets are in the study area.

Clay minerals are typically formed over long periods of time by the gradual chemical weathering of rocks, usually silicate-bearing by low concentrations of carbonic acid and other diluted solvents. These solvents, usually acidic, migrate through the weathering rock after leaching through upper weathered layers. In many places of the Nikola Oya it is possible to see goethite and hematite diluted solvents spring water pockets

(Figure 3). In addition to the weathering process, some clay minerals are formed by hydrothermal activity. Clay deposits may be formed in place as residual deposits in soil mainly from microbial activity, but thick deposits usually are formed as the result of a secondary sedimentary deposition process after they have been eroded and transported from their original location of formation.

In the Nikola Oya upper catchment, clay minerals are unstable and break down under intense chemical weathering to become *hydrated oxides* of Aluminum (bauxite) and Iron (goethite), which are very poor substitutes for clay minerals in retaining soil nutrients. As a result, jungle soil relies on the presence of humus, an organic substance produced by microbes that cause dead plants to decay; humus takes off the ability of clay minerals to retain soil moisture and nutrients.

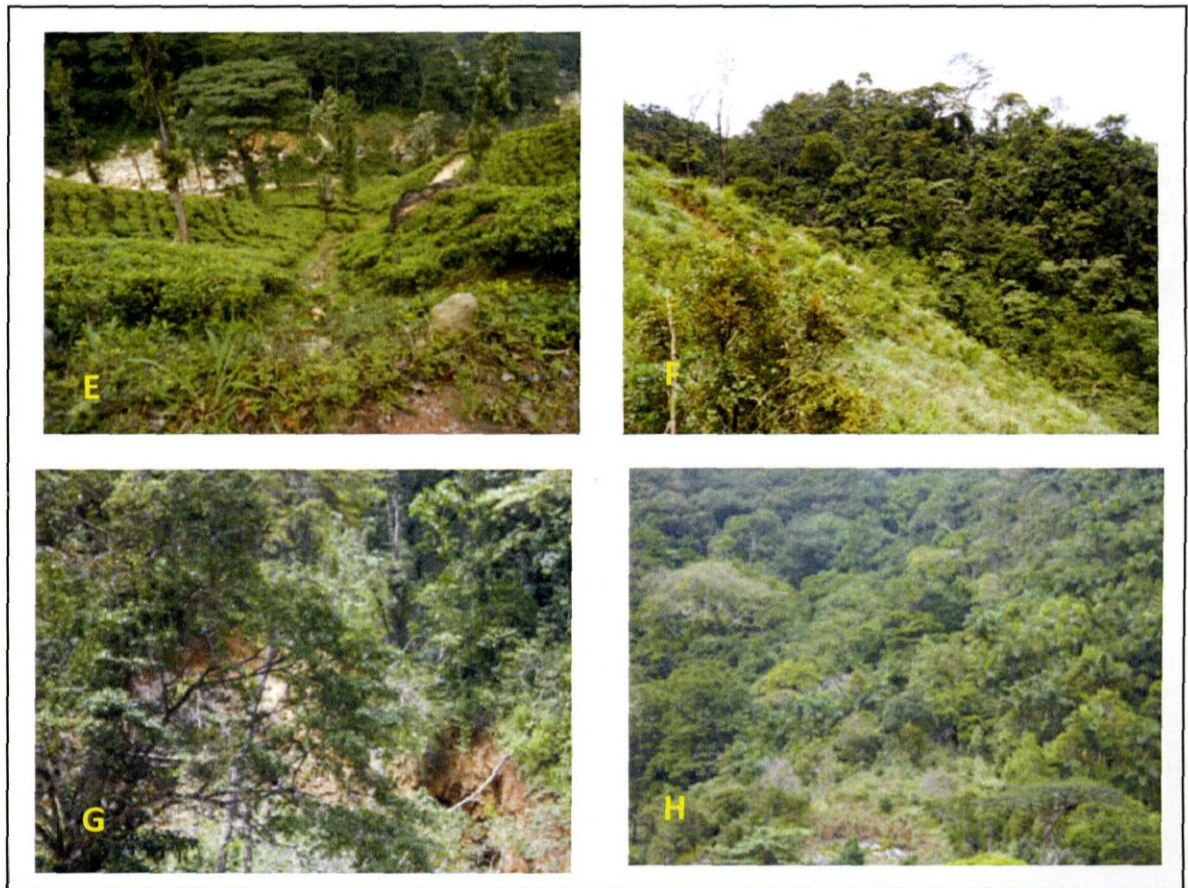
Figure 4 : There is no thick soil cover in old agricultural lands (tea plantations, E, F & G). A thin top soil layer (with humus) has developed in Sub Montane Forests (H) of the Nikola Oya catchment, but the thicknesses vary according to micro morphology of forestlands.

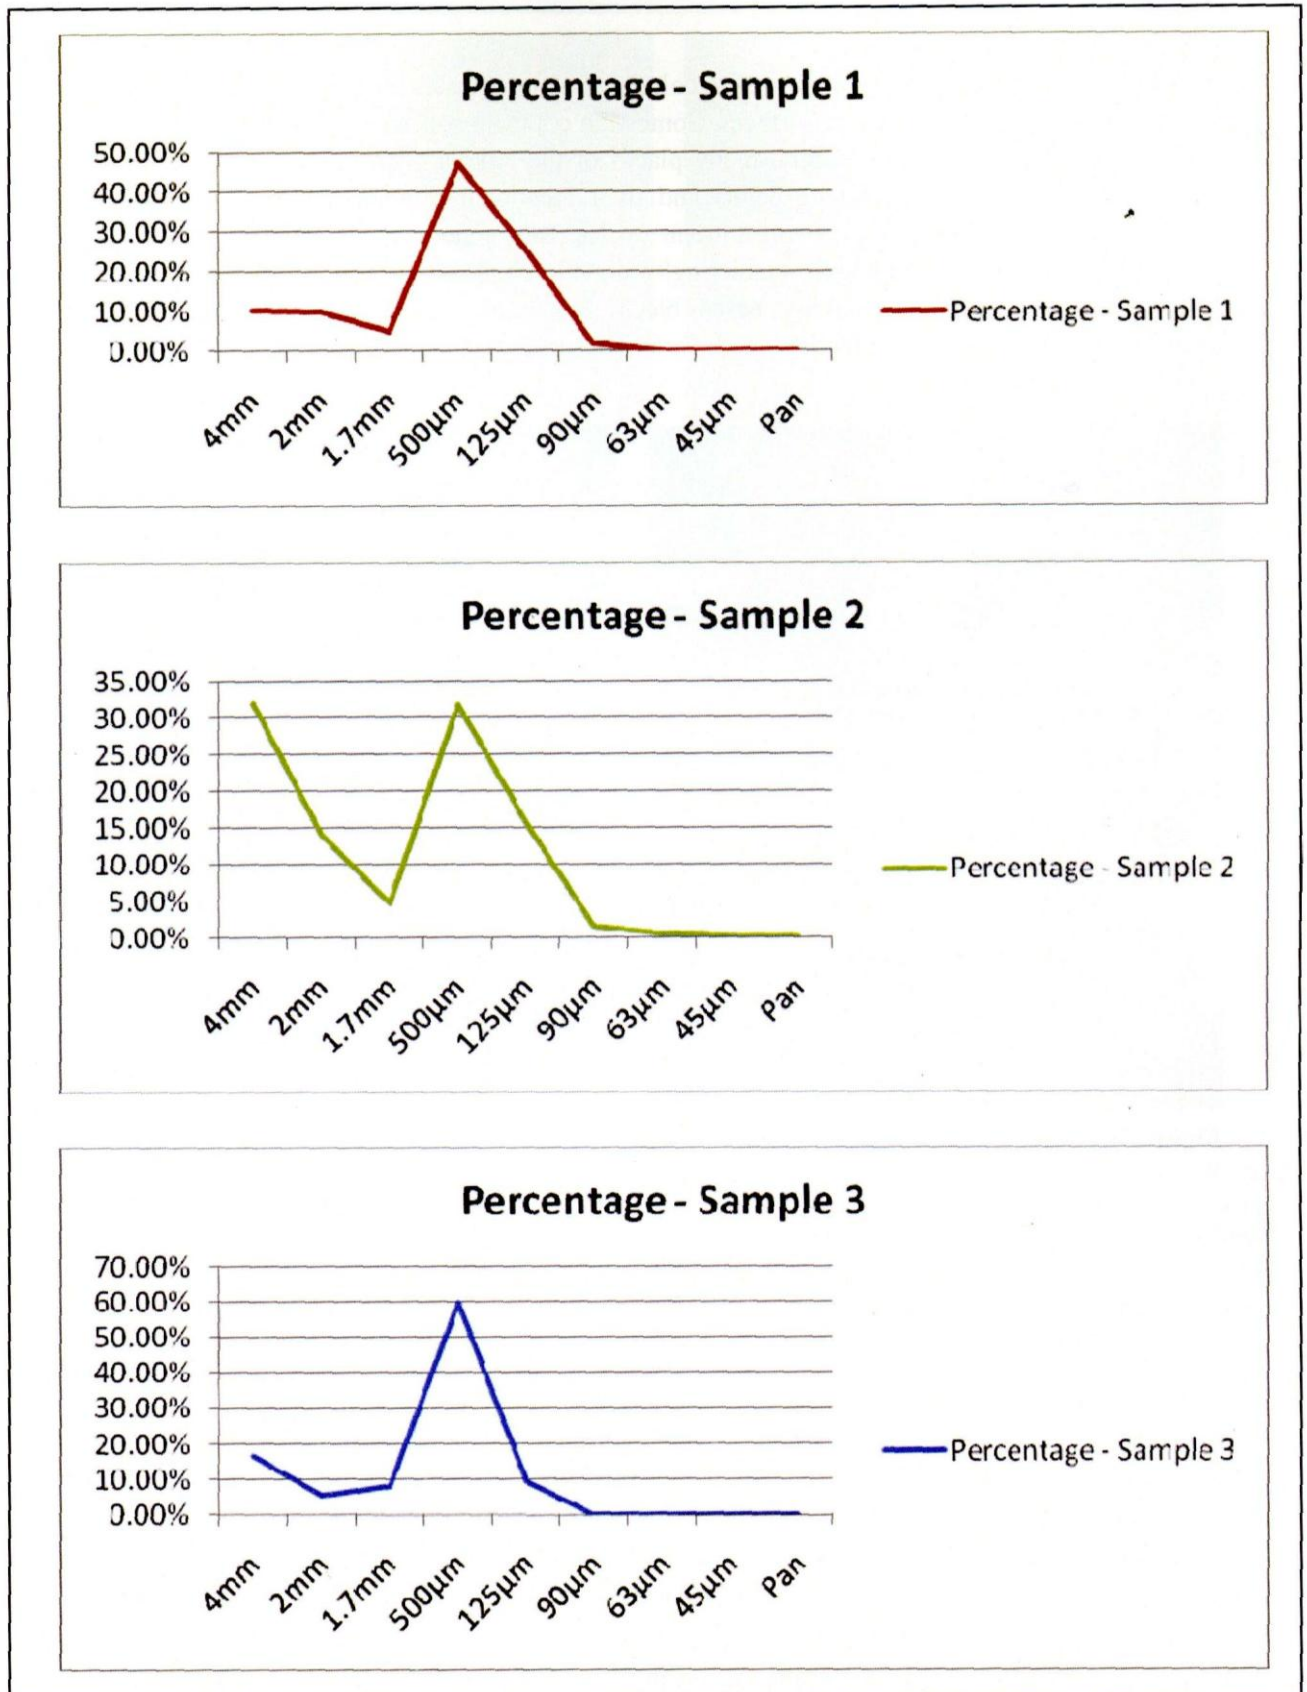
Figure 6 : Three soils samples collected from Nikola Oya (August 2013) indicate that top soils contain considerable amount of clay particles

Grain size distribution (Figure 6), shear strength and factor of safety (Fs) are very significant to maintain the soils in moderate to steep slopes. Three soils samples at Nikola Oya basin sites exhibited expansive potential, owing to clay contents well above 20%. A clay content exceeding 32% was identified at the debris flow sites implying an extremely high expansive potential of the soil (Table 1 and Figure 6). High liquid limits at upper catchment (headstreams) make the soils qualify as susceptible to landslides. The value of $Fs \geq 1$ for the headstream site signifies an inherently unstable slope, and unstable conditions interplay of various physical, geological, pedological and anthropogenic factors.

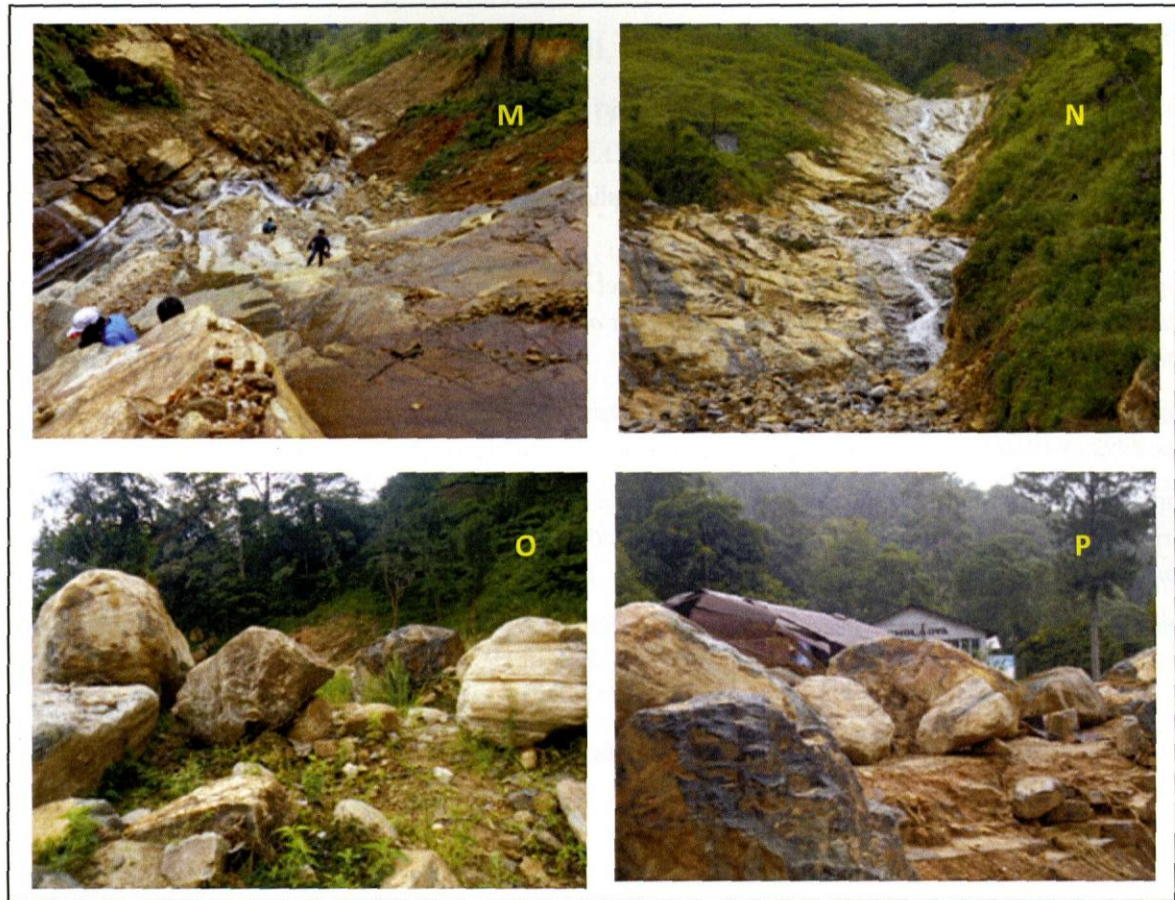
Figure 8: Photos M – P prove that heavy abrasion process continues during the flowing of debris on bedrock related river beds. The broken rocks scatter in low slopes and damage the houses and other property.

During the debris flow along the stream bed heavy abrasion process continued. By this mean, huge boulders rolling and collision fall to downward with other debris. Accordingly, some places of the stream bed appear gneissic bedrock surfaces and both sides show that there are no soil layers. The banded quartzite layers have broken due to the flowing of debris at this time, and boulders roll further down damaging houses and other properties located along the banks Figure 8.
