PROCEEDINGS OF THE NATIONAL SYMPOSIUM  
ON LANDSLIDES IN SRI LANKA

## Landslides in Sri Lanka in the 21st Century

Jinadasa Katupotha  
Department of Geography  
University of Jeyawardenepura

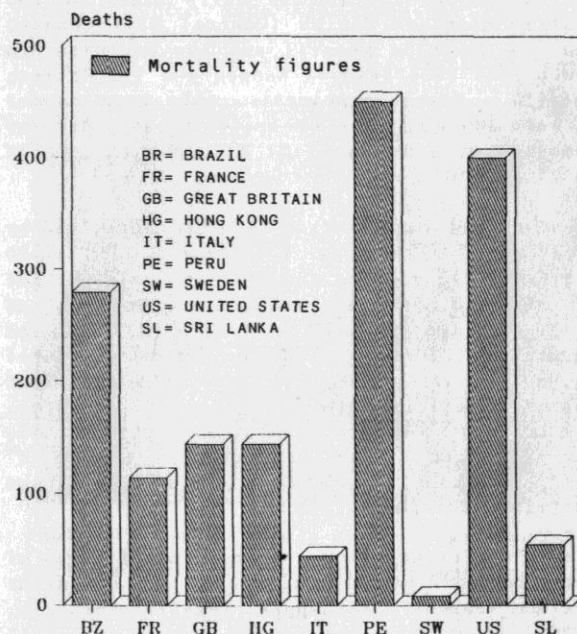
Figure 1. Mortality figures due to mass movements from 1966 to 1987.

Among the natural hazards (earthquakes, seismic sea waves, volcanic eruptions, catastrophic winds, sea fog, sea ice and iceberg drift) landslides are least documented and researched. This could be because of the occurrence of landslides in restricted areas and inadequacy of statistics (WMNH, 1988; Fig. 1). However, large landslides, involving millions or even billions of cubic meters of debris movement can damage the natural environment, destroying life and property within a short period of time. The environmental damage caused by landslides has been intensified during the last 15-20 year period as a result of the inadequate investigations of geological structure during reservoir and road construction, short-sighted land policies and recent over-exploitation of natural forest resources of the uplands and mountainous areas. The use of high explosives for the mining of graphite, dolomite and other metals as well as mining of gems beyond the

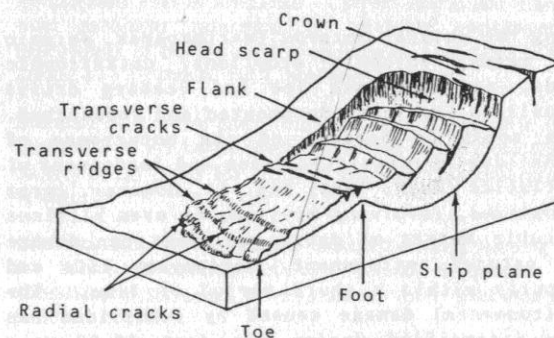
Figure 2. Features of a landslide.

Several visible indicators can be applied to identification slide, fall and flow of rocks, earth and debris in steep slopes. Formation of cracks and fractures, especially as transverse cracks on Convex Creep Slope and Free Face on the crown, encourages seepage of rain-water down to the weathered bedrock layer (Figs. 2 & 3). If there are iron-rich clay materials between bedrock and the top soil layer, lubrication of weathered material and blocks of cracked rock move downwards by force of gravity (Plate 1).

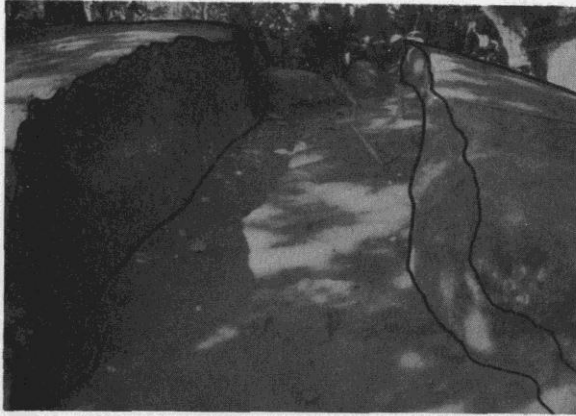
Plate 1. Cracked rock at Palankanda (Opanayaka) indicates the gradual movement of the landmass.

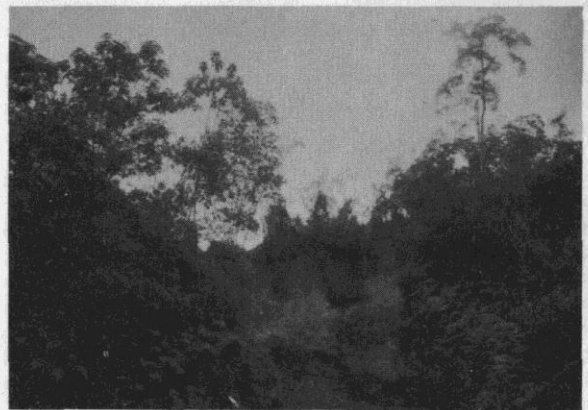
Plate 2. Slope failure at Nivitigala, 1993.

When the soils of steep slopes are saturated, the bond between bedrock and weathered top soil is broken. Consequently, the vegetation cover would wither due to the petrification of the root-system. This is also indication a slope failure during the heavy rains (Plate 2). Furthermore, gradually inclining wire poles, telephone and electric wire poles, masonry walls, cracked rocks of the convex creep slopes and the free face (Fig. 3). Cracked retaining walls and foundations on fair to moderate and steep slopes also indicate future landslides prone localities.

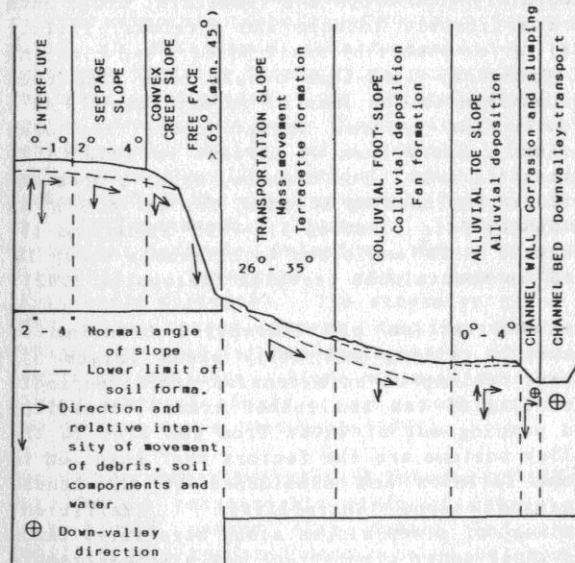
Figure 3. Slope units on a hypothetical land surface (Whittow 1984). Convex creep slope and free face are mainly subjected to landslide.

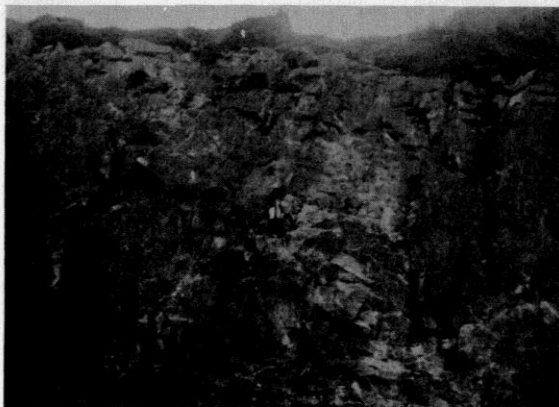
Plate 3. Blasting of highly metamorphosed rocks (Kurunegala - Matale Road): a potential landslide location.

The construction of reservoirs, blasting of rocks in rolling and hilly areas (Plate 3), forest felling on an extensive scale, periodic uprooting of tea and rubber trees, tunnelling and pumping out of water from gem pits in the valley bottoms are the factors that have led to slope failures and subsidence of the lands, creating slope instability. Inefficient drainage of steep slopes along bare rocky lands and those under plantations may also contribute to slope failure.

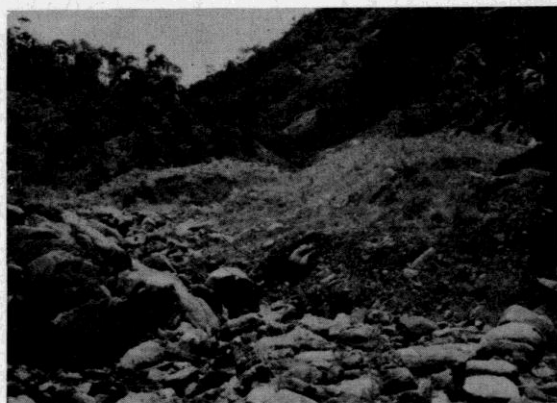
Plate 4. Movement of thousand tons of debris and rock blocks during excessive rains (1989) deposited in a small valley bottom at Hettikanda (Hinidunkanda) in the Ratnapura district more than one kilometer distance.

During the same excessive rains, the bedrock-related materials (debris and boulder) have been moved at Hettikanda (Hinidunkanda) in the Ratnapura district (Plate 4) and at Berannewa in the Kegalle district. As a consequence, 24 deaths occurred and paddy fields were covered by boulder-rocks slide with earth flow at Bambaragala (Kegalle district) during the same period. Debris and earth movements have occurred at Atalugankanda, Punugala, Minimaruwa, Gatemulla, Warawela, Malmaduwa, Makura (Kegalle district), Wewalgama and Dodamgahaela (Kurunegala district). The excessive rains in 1989 also caused damage to the Kandy - Mahiyangana road (at Hunnasgiriya) by displaced debris and boulders. Slope movement in several places appeared singly or as a combination of two or more types (Katupotha 1991).

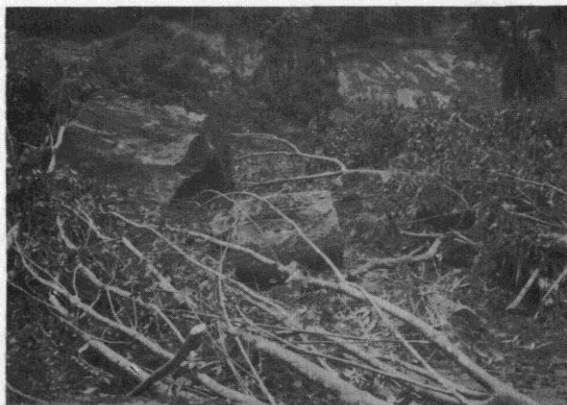
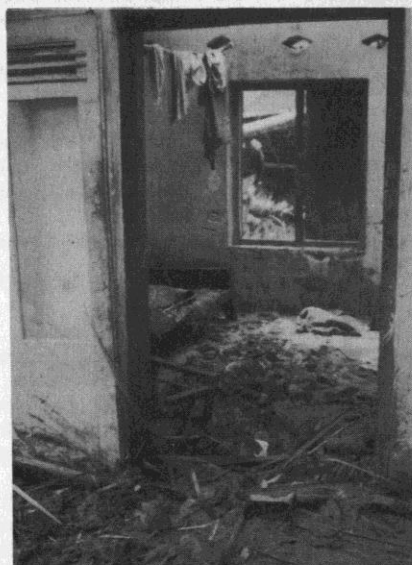
Plate 5. (A) Location of the area where a catastrophic landslide caused damage to three houses and caused five deaths in Bulathsinhala (Kalutara district), 1992. (B) Damaged rooms in one of the houses shown in Plate 2 B area.

Due to the excessive rainfall between 25 and 30 May 1992, a catastrophic slide of debris and rock blocks caused five deaths and three families were rendered destitute at Bulathsinhala in the Kalutara district (Plates 5A & 5B). A major landslide at Helauadakanda in the Ratnapura district caused about 32 deaths and the destitution of 300 persons in October 1993.

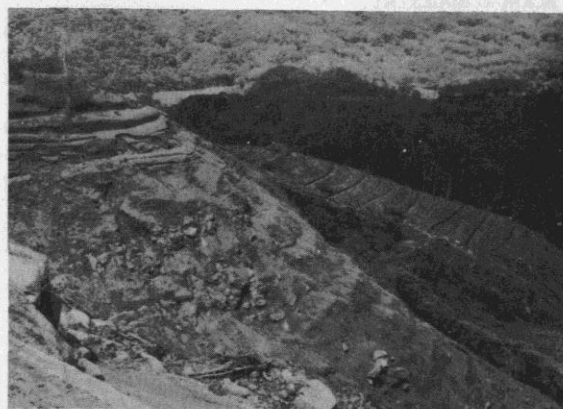
Plate 6. (B.2) clearance of forests at Kukulegama (Ratnapura District): a potential landslide location.
