## COASTAL PROCESSES AND CAUSES OF SHORELINE EROSION AND ACCRETION OF THE BATHTHALANGUNDUWA ISLAND IN SRI LANKA

**KEY WORDS:** Dynamic environment, Monsoons, Flandrian Transgression, Climate change

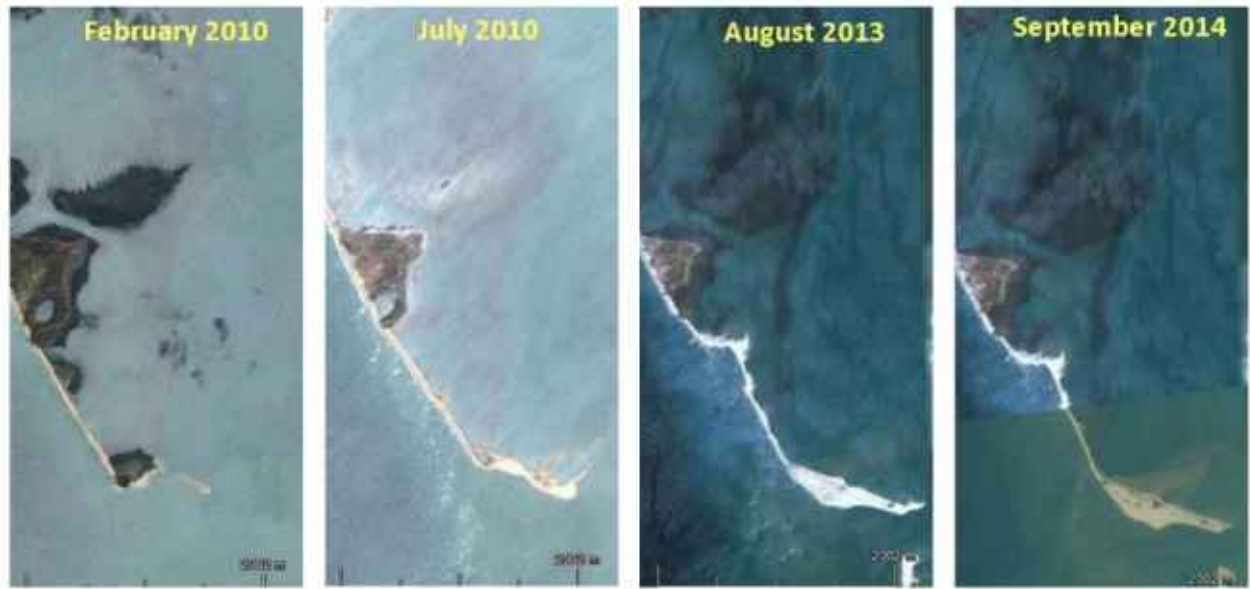
**Figure 5.** Changes of the Southern Tip of the Baththalangunduwa Island  
(Source: Google Earth).

mentioned, as an example the severe coastal erosion, which occurred during the southwest monsoon storms in 2016 year (Photographs G-L). Google images also reveal that the extending the island northwards and developing eastwards the island (Figures 4 & 5).

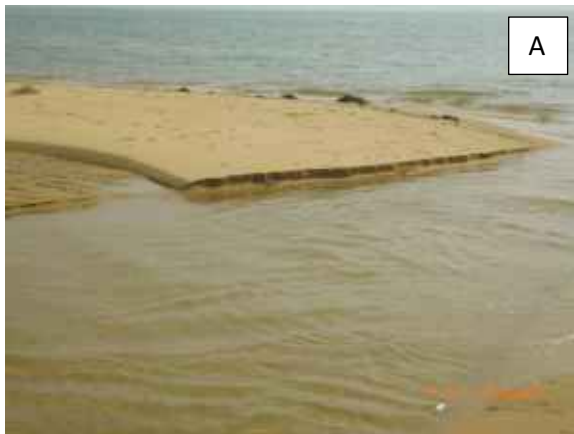
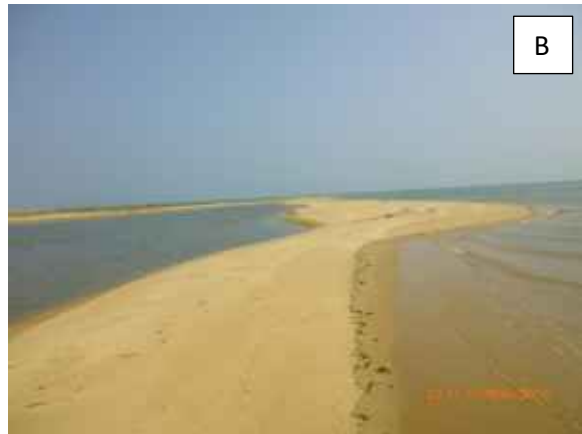
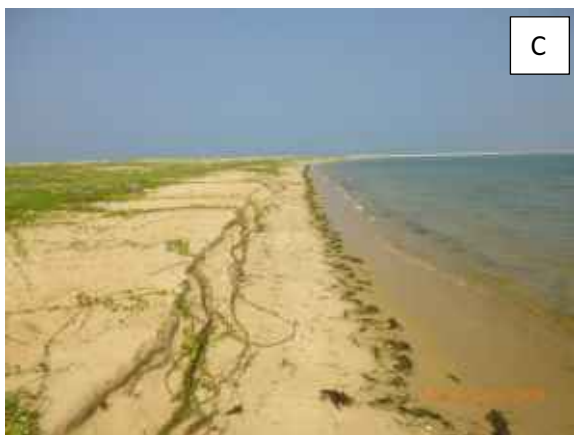
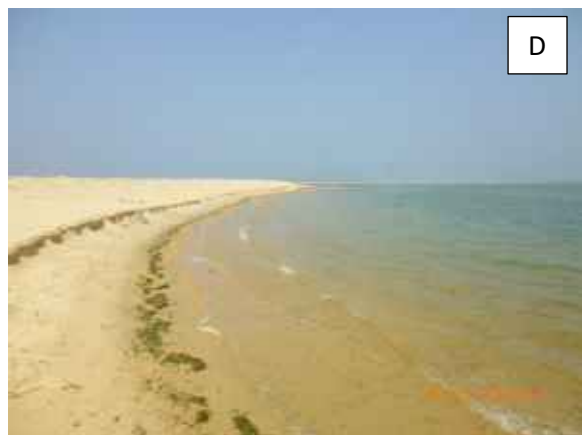
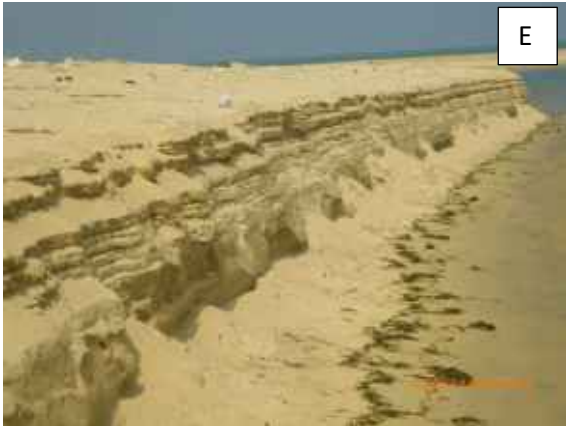
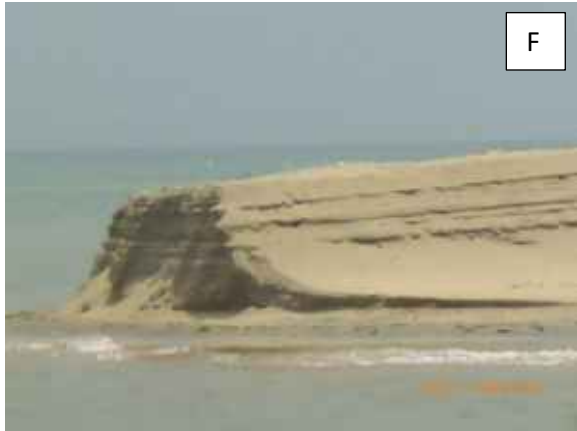
Coastal erosion along the eastern flank of the Baththalangunduwa island (Photographs A-F).

**Photographs A – F:** Eastern Margin of the Island has Eroded as Pockets by Diurnal Tidal Prism, Waves and Long Shore Currents.

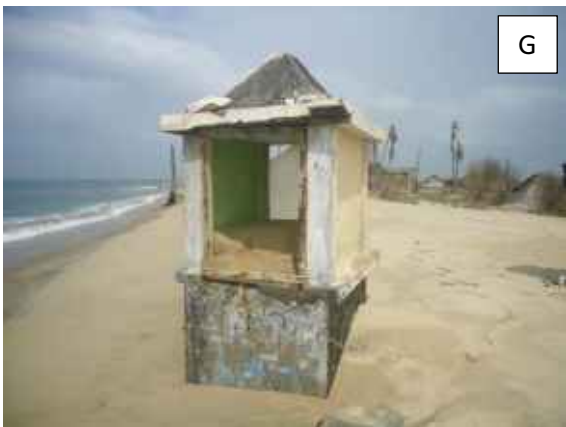
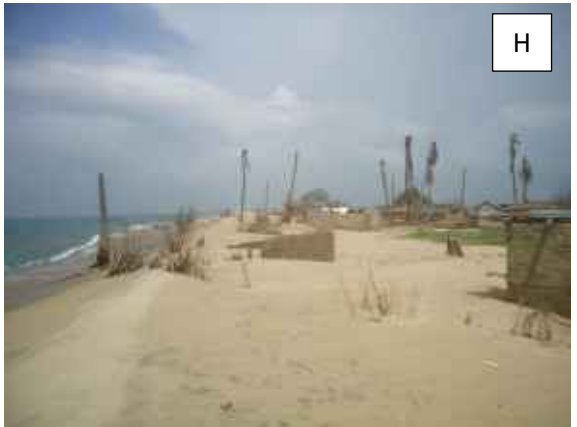
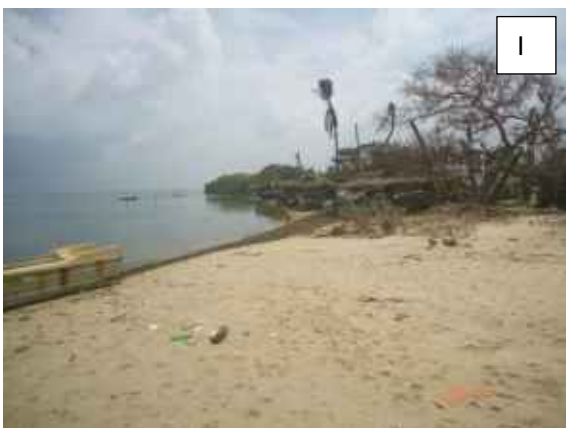
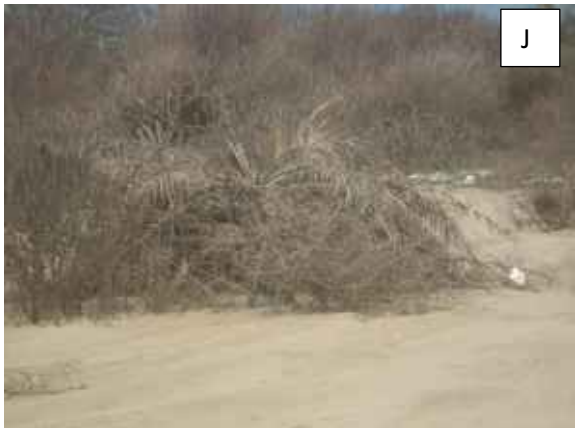
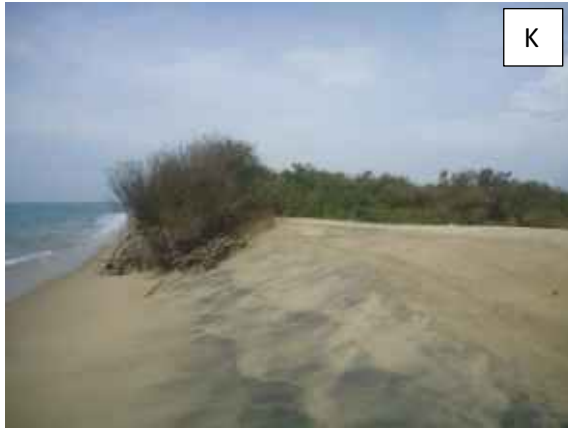
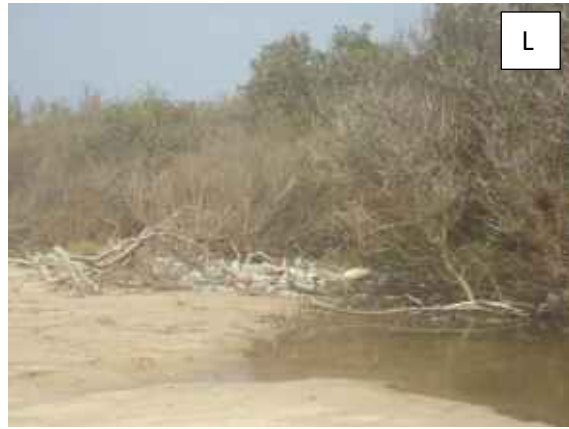
Coastal erosion along the western flank of the Baththalanguduwa island (Photographs G-L).

**Photographs G – L: Severe Erosion Along the Western Coastal Flank of the Baththalangunduwa Island by Storm Surges in 2016.**

The depicted photographs clearly show this destructive activity. By this mean, fishing huts and semi permanent building were damaged and displace the hundreds of inhabitants. Likewise, we found that some changes have occurred northern part of the island (Figure 4).
